## ***Lost Creek, SR 101, MP 174***

## **Design Solution**

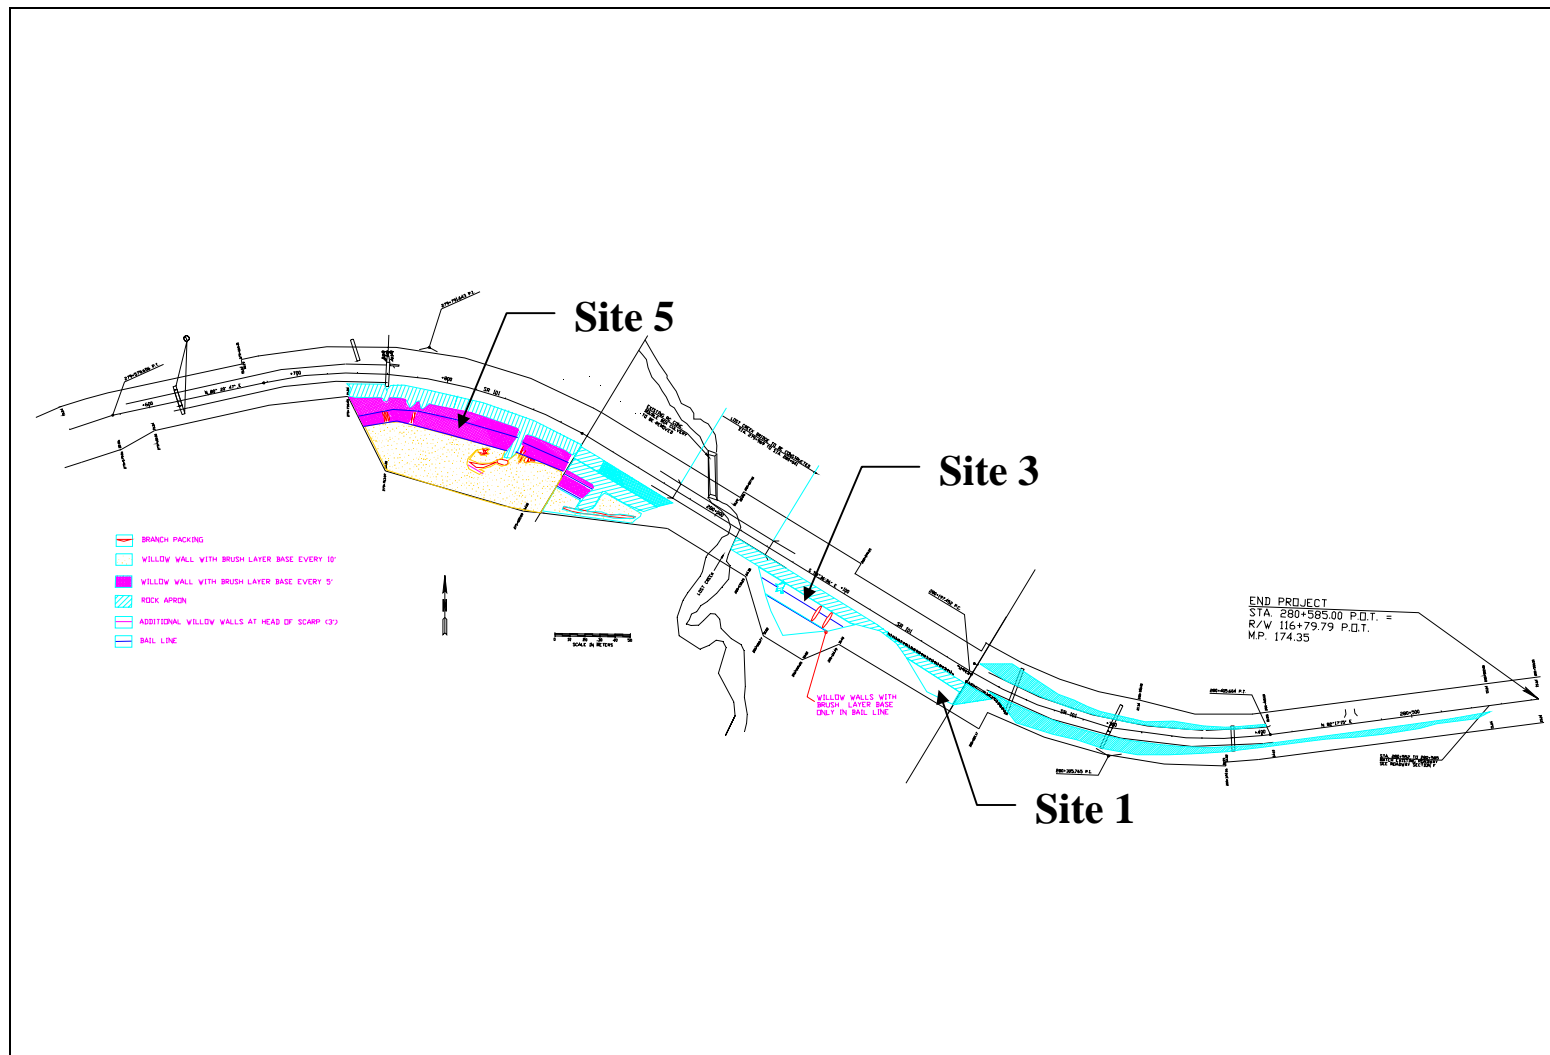
Figure 9. Lost Creek Project Areas

The Lost Creek project was divided into three sub-sites, Site 1, Site 3, and Site 5. Locations of these sites are shown in Figure 9.

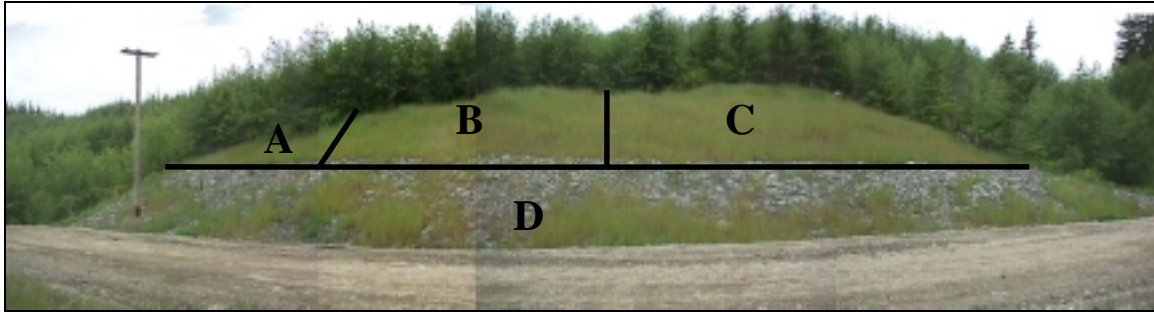
**Figure 10. Site 1**

The slope had rills and gullies and a shallow rapid landslide with a head scarp near the top of the cut slope. The dense and heavily compacted marine clay presented challenges to all involved, especially the Crews. Prior to the start of the research project, the geological engineer and project manager had placed a rock apron at the base of the slope to counter-weight the slope and to prevent further movement.

Two parallel lines of hay bales had been placed on the slope, approximately along the contours. These had apparently slipped and the resulting downward slope of the bales was channeling surface water to the end of the hay bale row and in addition, water was seeping from between the bales. Exit points of these, concentrated water flows and resulted in small rill and gully formations.

Plant trees (20%) and shrubs (80%) at minimum of 4 foot x 4 foot spacing.  
Species mix has been selected. RA and WSDOT Landscape Architects will determine placement and spacing.

Dimensions: 10 foot length and 2 foot height or 5 foot to 6 foot length and 2 foot height. Use 3 foot to 4 foot long willows for stakes to support fencing. Follow instructions in attached technical manual. Once constructed, fill behind *willow fence* with soil (preferably a silt loam). Plant shrubs and small trees (i.e. dogwood) within these terraces.

Create planting “islands” by constructing *willow fence* and *willow fences with a brush layer base*. As noted on the design, locate the *willow fence with a brush layer base* above rocky gullies. Once constructed, fill behind *willow fence with a brush layer base* with soil (preferably a silt loam). Plant shrubs and small trees (i.e. dogwood) within these terraces.

Install live stakes in rock apron. Use stems 1.5 inches to 3 inches in diameter and 2 feet to 3 feet long. Space 2' to 3' apart and tamp into the ground at right angles to the slope. Four-fifths of the stem should be installed into soil. Firm soil around the stem. Trim any splits. If needed, use an iron bar to pilot a hole.

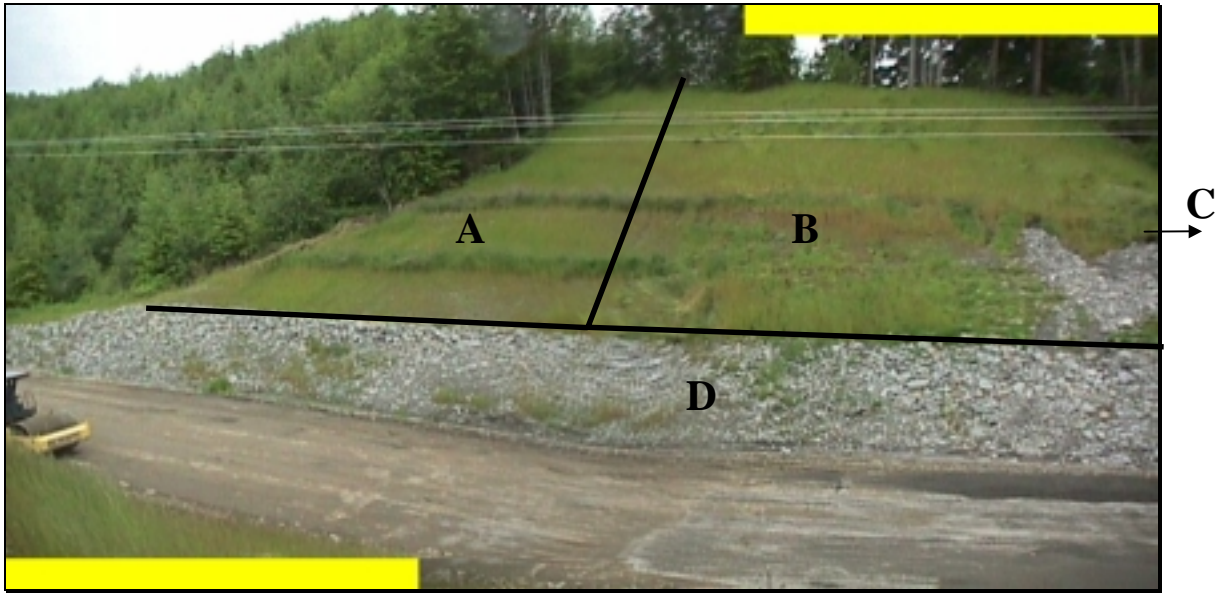
Figure 11. Site 3

Grasses were effective in stabilizing surface erosion of upper B section. Below this upper section, however, grasses had minimal effect in preventing erosion. Within Site 1, Section C experienced the highest level of surface erosion (rills and gullies). This erosion was caused by overland flow and insufficient plant cover and root development. To maintain stability, inhibit additional surface erosion, and prevent shallow rapid landsliding:

Grasses were effective in stabilizing surface erosion of upper C section. Saturated soils, however, led to small shallow rapid landslide located in center C section. To inhibit area from enlarging and stabilize feature:

- Remove all hay bales and rake smooth trapped silts.
- Plant trees (30%) and shrubs (70%) throughout Section A. *Use predominantly (90+%) shrubs in terraced areas behind willow fence.* Plant species have been selected and approved. RA and WSDOT Landscape Architects will determine placement and spacing (minimum 4'x4'). PI will review to make sure placement and spacing meets slope stability objectives.

Starting above rock apron, construct continuous row of *willow fence*.

Starting above rock apron, construct continuous row of *willow fence with a brush layer base*.

Construct “live gully repairs” in all gullies, except the one already filled with rock. Use willow stems 1 inch to 2 inch diameter and length determined by depth of gully. Additional instructions can be found in the soil bioengineering technical manual.

Install “branch packing” in shallow rapid landslide. Use willow stems ½ inch to 2 inch diameter. Additional instructions can be found in the soil bioengineering technical manual.

Starting at rock apron, construct continuous rows of *willow fence with a brush layer base*.

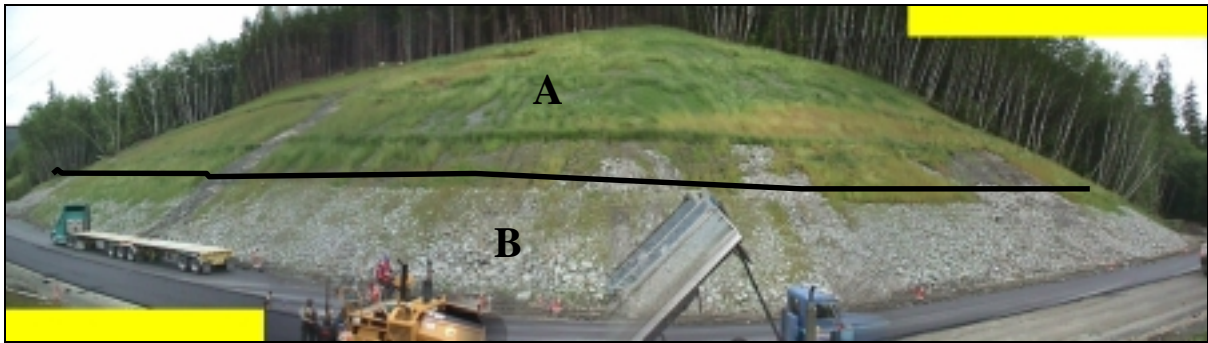
**Figure 12. Site 5 before treatment**

Grass minimized surface erosion. Within Site 5, Section A experienced the highest level of surface erosion. This erosion was caused by high rainfall and subsequent saturated soils. This condition led to excess overland flow and draining hay bales. There was insufficient plant cover and root development to maintain slope stability. To inhibit additional surface erosion and shallow rapid landsliding:

Concurrent with this decision, the head scarp on Site 5 began rapidly moving, this rotational failure moved 10-15 feet within a week. A WSDOT geotechnical engineer was brought in, and upon field review, placed this site on WSDOT's list of major erosion sites to be considered for engineering solutions. This confirmed the PI's decision to discontinue soil bioengineering on Site 5.

- Remove all hay bales and rake smooth trapped silts.
- Create planting “islands” by constructing (*willow fence with a brush layer base*). Once constructed, fill behind *willow fence with a brush layer base* with soil (preferably a silt loam). Plant shrubs and small trees (i.e. dogwood) within these terraces.

Install “branchpacking” in shallow rapid landslide. Use willow stems ½ inch to 2 inch diameter. Additional instructions can be found in the soil bioengineering technical manual.

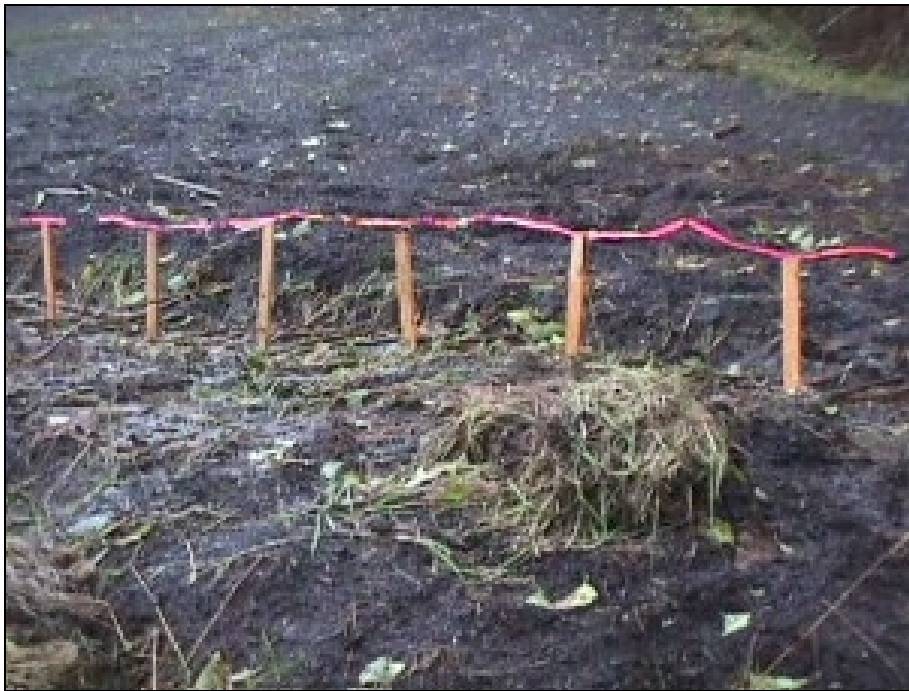
**Figure 13. Site 3 - Stakes placed below level terrace marking tape**

The original plan called for willow wall construction in the same general location as existing hay bales. However, the hay bale rows were not level and encouraged runoff beginning from the center of the hay bale row and extending to the edges of each row. This resulted in erosion of material from behind the hay bales and at each end. After consultation with the PI, the Crew was to begin at the highest point of the hay bale row and continue constructing the willow walls level with that highest point. The RA used a laser level to stake all terraces for the Crews with pink flagging tape as seen in Figure 13. At this point, the RA had to leave for Chelan. While she was gone, the Crew did not follow the RA's instructions and continued to construct the willow wall in the straw bale line. The Crew constructed two additional rows of willow wall that were also not level. The Crew did not understand how to keep the terraces level on a convex surface. For example, Figure 13, below, shows the marking tape where the wall should have been constructed above and behind the stakes the Crew placed.

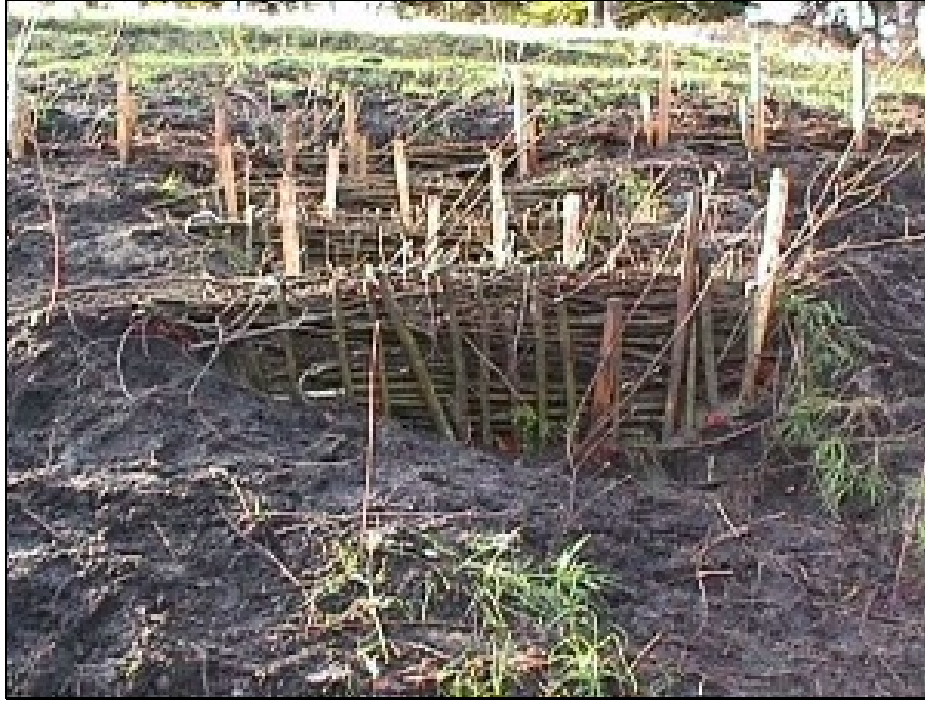
**Figure 14. Branch packing Parallel to Contours**

Due to the amount of surface water received by the gullies on Site 3, the original branch packing design washed out. Additional willow walls were constructed at the head of this gully and the branch packing design was changed to the design seen below.

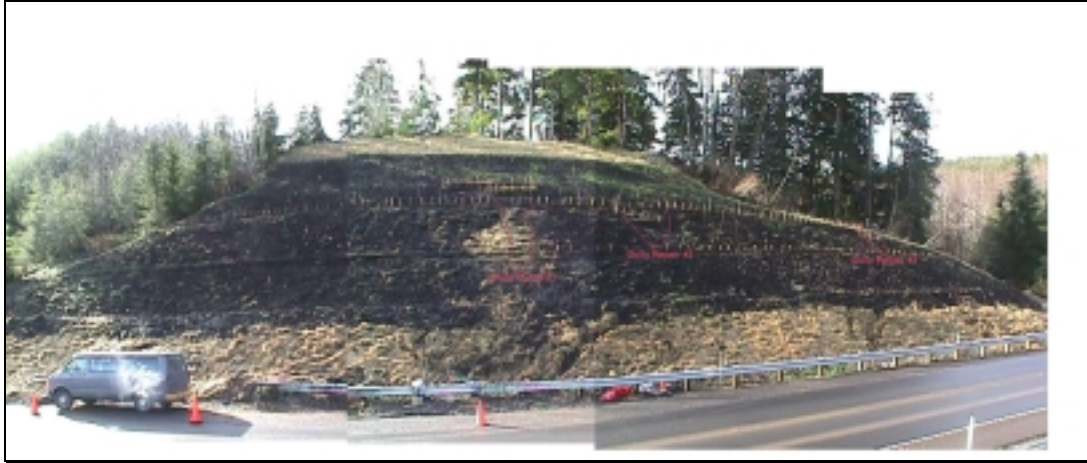
**Figure 15. Site 3 Immediately After Construction**

Construction concluded on Site 3 on January 27, 2000. Native vegetation was planted on Site 3 the week of January 24.

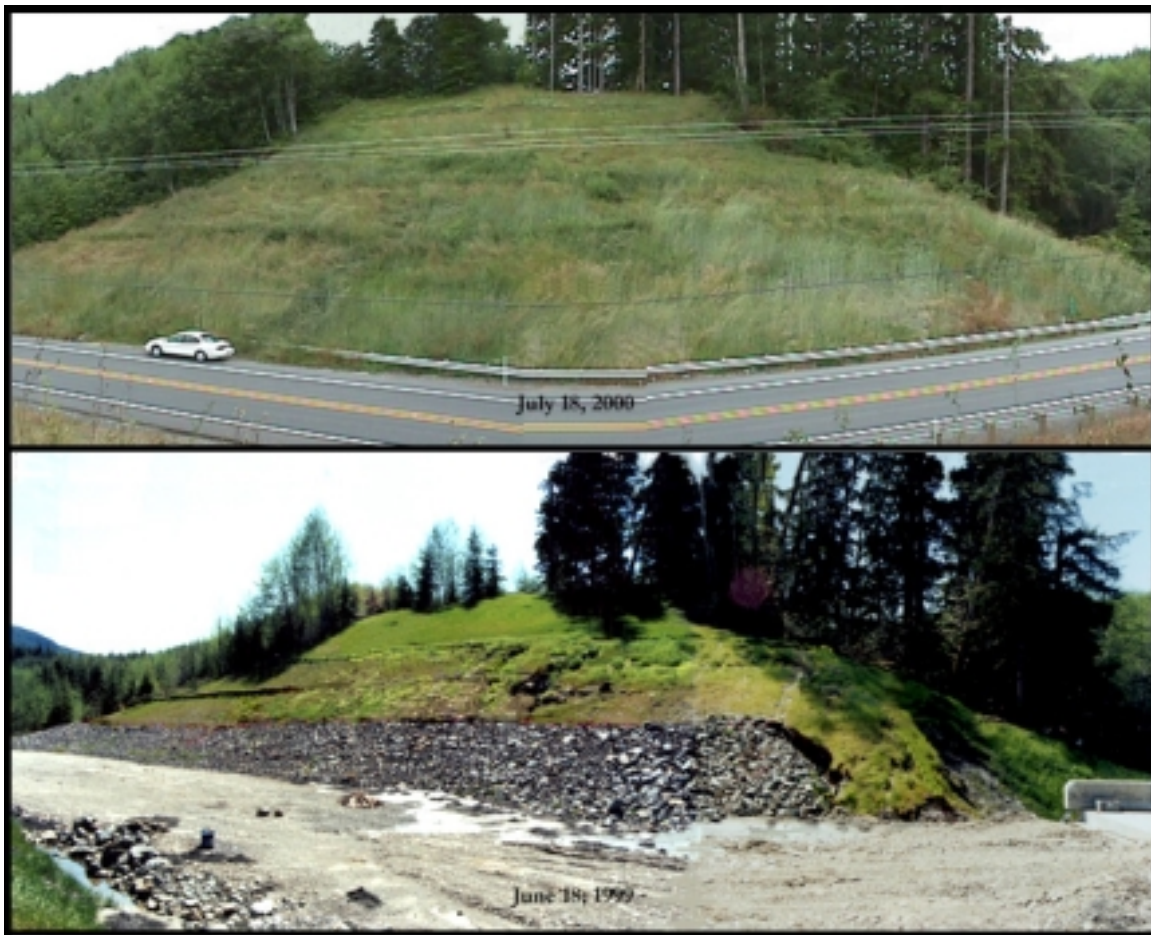
**Figure 16. Site 3 Before and After Soil Bioengineering**

In Figure 16 the top photo shows the site 6 months after construction. The lower photo shows the site prior to construction.

As of July, the head scarp was stabilizing with grasses, shrubs, trees, and willow structures.

- Trend is improving to stable
- No evidence of mass movement or gully erosion.
- Site is showing 95% vegetative cover.
- Brushlayer survivability:
  - Brushlayer structures - 80% show new growth.
  - Willow wall structures – 40% show new growth.
- Survivability of vegetation on terraces:
  - Uniform survival above rock apron – 70% overall.
- Uniform survival within the rock apron – 40% overall.
